**Flood Control Project Maintenance
Levee Inspections**

Fall 2010 Levee Maintenance Deficiency Summary Report

Sacramento River Basin

Reclamation District No. 0349 Sutter Island

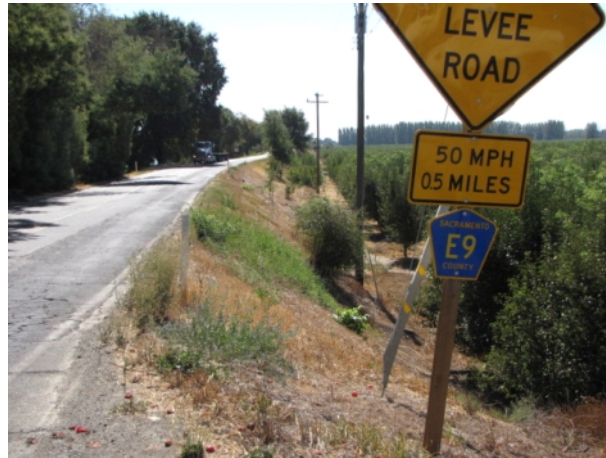
Levee Mile Report Line	1
Start Levee Mile	0.00
End Levee Mile	0.00
Location	Land Side
Category	Earthen Levee
Item	Vegetation

Land side levee at levee mile 0.00 RD 349 Unit 1 Sacramento. Levee slopes were mowed prior to FALL inspection , Photo taken 09-29-2010

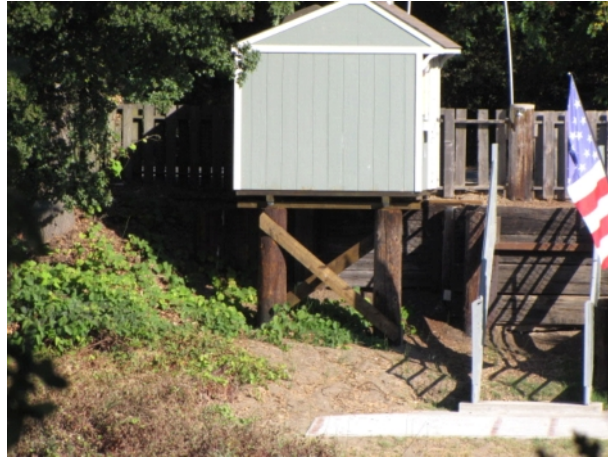
Levee Mile Report Line	1
Start Levee Mile	0.02
End Levee Mile	0.02
Location	Water Side
Category	Earthen Levee
Item	Encroachments

This is viewed from across channel RD 3.
Building sitting on Pilings water side.

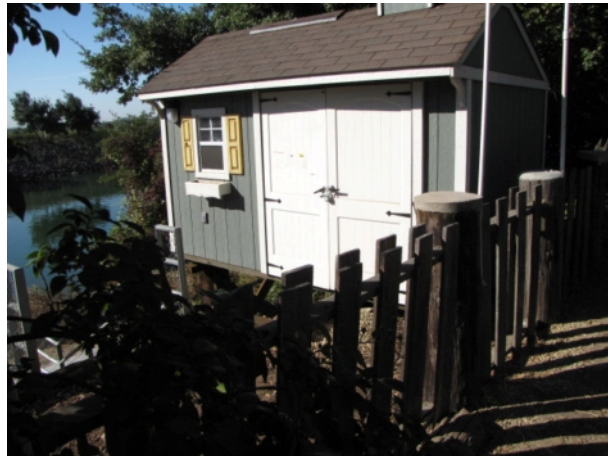
Levee Mile Report Line	1
Start Levee Mile	0.02
End Levee Mile	0.02
Location	Water Side
Category	Earthen Levee
Item	Encroachments

Unauthorized Building on water side levee mile
0.02 RD 349 Unit 2.

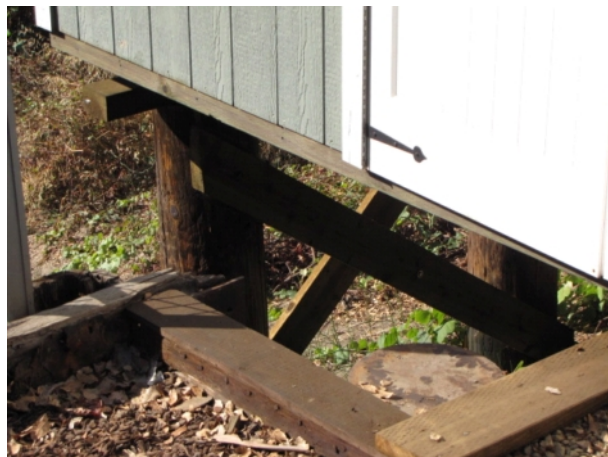
Levee Mile Report Line	1
Start Levee Mile	0.02
End Levee Mile	0.02
Location	Water Side
Category	Earthen Levee
Item	Encroachments

This photo shows the piling that the building is
resting upon.

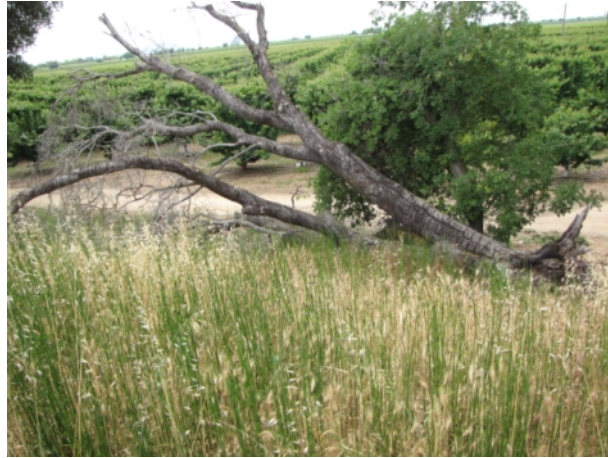
Levee Mile Report Line	15
Start Levee Mile	1.63
End Levee Mile	1.63
Location	Land Side
Category	Earthen Levee
Item	Encroachments

This tree was on the levee slope during my last inspection, the District has been told to remove it, it still remains today. No attempt has been made to remove.

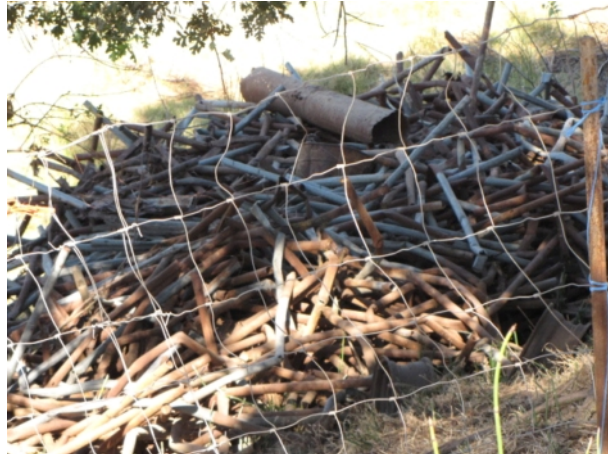
Levee Mile Report Line	22
Start Levee Mile	3.39
End Levee Mile	3.40
Location	Land Side
Category	Earthen Levee
Item	Encroachments

Old pipe stocked on land ward slope unit 2 levee mile 3.39-3.40.

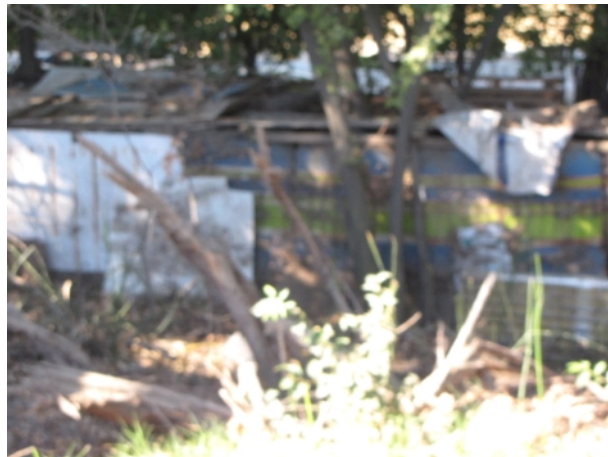
Levee Mile Report Line	27
Start Levee Mile	3.75
End Levee Mile	3.77
Location	Land Side
Category	Earthen Levee
Item	Encroachments

Building, chicken pins and goat pins at toe of levee 3.74- 3.78

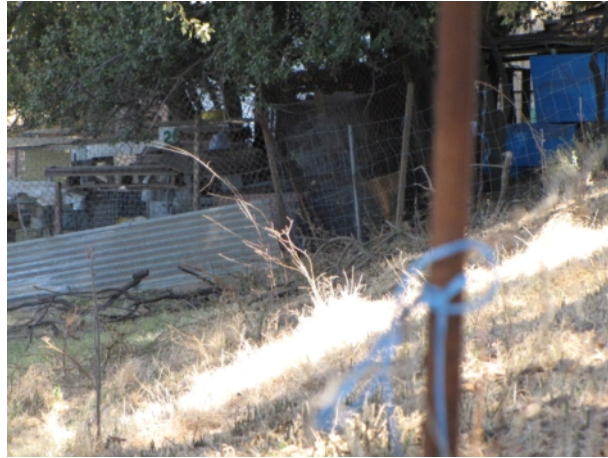
Levee Mile Report Line	27
Start Levee Mile	3.75
End Levee Mile	3.77
Location	Land Side
Category	Earthen Levee
Item	Encroachments

This photo shows fence at right bottom and the tin in back ground is part of another pin. The top right side of photo shows the corner of a building of slope. The equipment is shown in back side of fence.

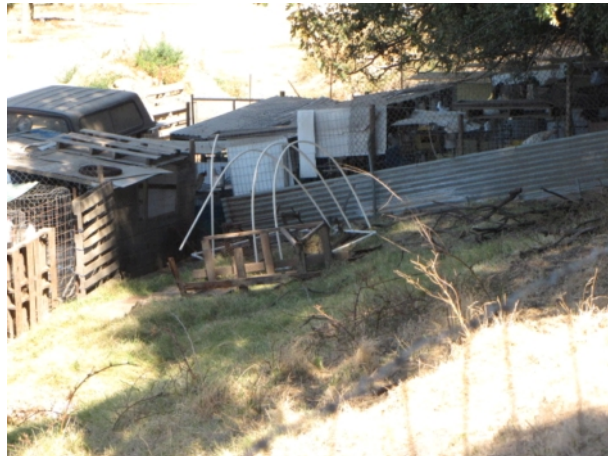
Levee Mile Report Line	27
Start Levee Mile	3.75
End Levee Mile	3.77
Location	Land Side
Category	Earthen Levee
Item	Encroachments

This photo shows the material on slope along with cages for goats and chickens.

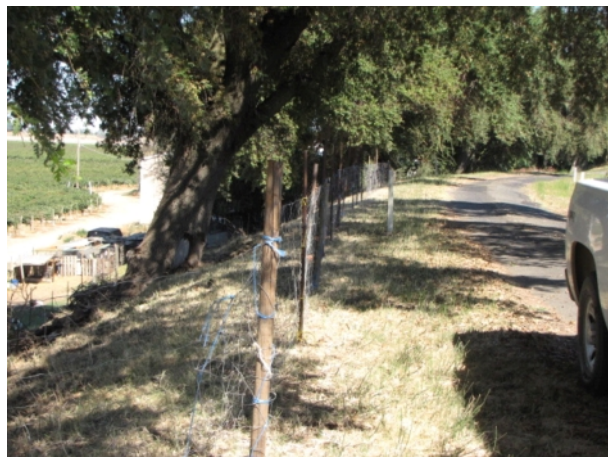
Levee Mile Report Line	29
Start Levee Mile	3.78
End Levee Mile	3.78
Location	Land Side
Category	Earthen Levee
Item	Encroachments

This fence has no permit, the land owner moves it from time to time he keeps goats inside of it..

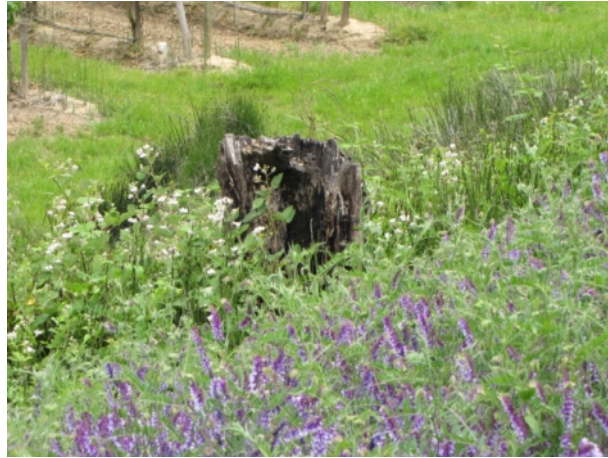
Levee Mile Report Line	1
Start Levee Mile	0.62
End Levee Mile	0.62
Location	Land Side
Category	Earthen Levee
Item	Trim / Thin Trees

This stump is located on the landward slope.

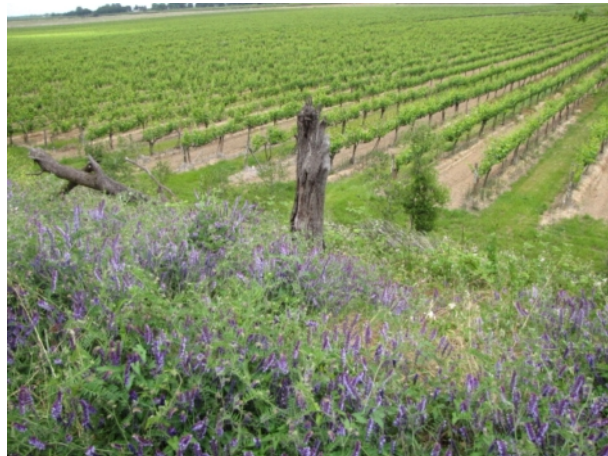
Levee Mile Report Line	2
Start Levee Mile	0.63
End Levee Mile	0.63
Location	Land Side
Category	Earthen Levee
Item	Trim / Thin Trees

Broken tree with stump on landward slope, broken top portion of this tree is resting on the landward toe. District is aware of this encroachment.
